EXECUTIVE SUMMARY

OBSERVATIONS & RECOMMENDATIONS

Forest Lake, Winchester

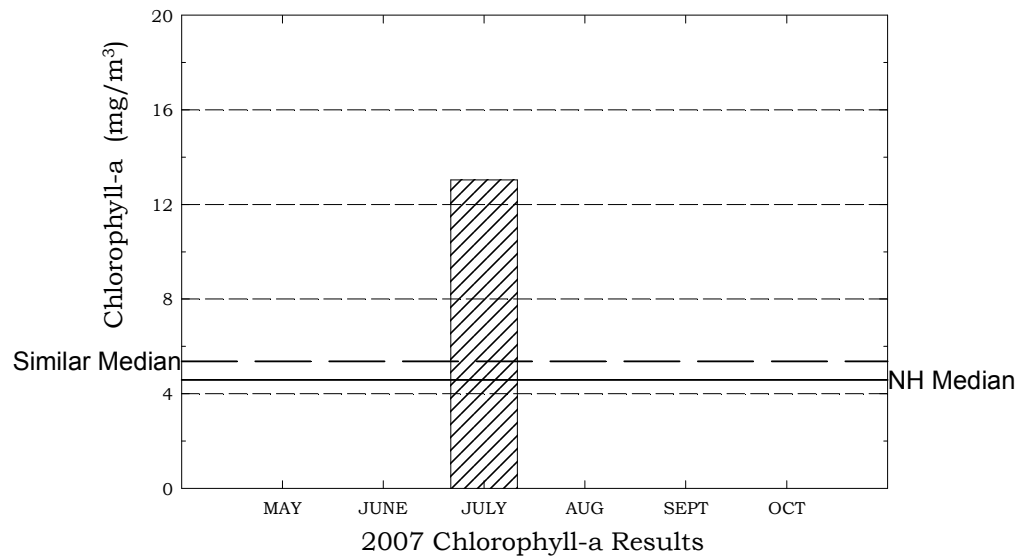
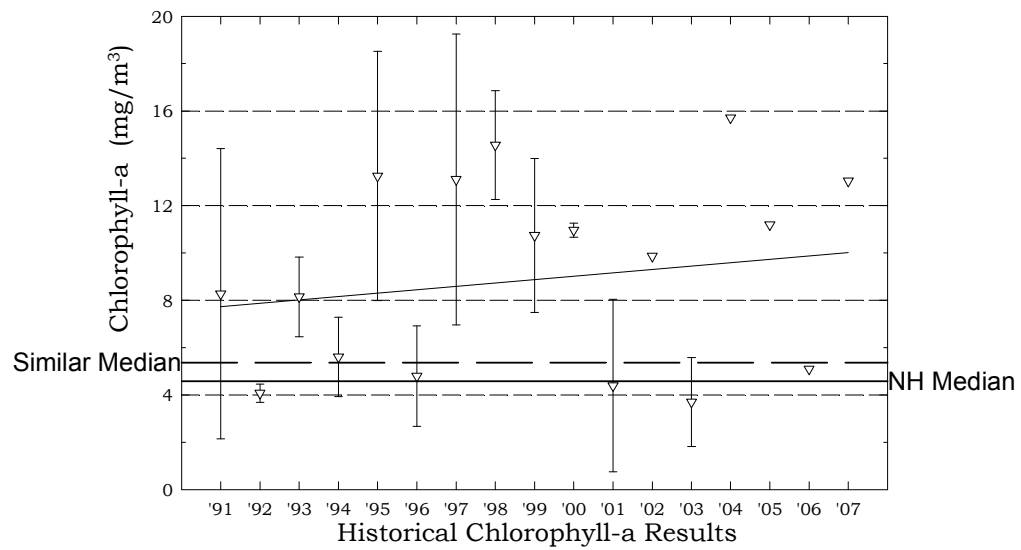
Figure 1. Monthly and Historical Chlorophyll-a Results

Figure 1 depicts the historical and current year chlorophyll-a concentration in the water column.

The current year data (the top graph) show that the chlorophyll-a concentration was **13.0 mg/m³** in **July**. Typically, chlorophyll-a concentration above 15 mg/m³ indicates an algal bloom is occurring. The July data indicate the potential for bloom conditions in late summer.

The historical data (the bottom graph) show that the **2007** chlorophyll-a is ***much greater than*** the state and similar lake medians. For more information on the similar lake median, refer to Appendix D.

Overall, visual inspection of the historical data trend line (the bottom graph) shows an ***increasing*** in-lake chlorophyll-a trend since monitoring began. Specifically the mean chlorophyll concentration has ***worsened*** since **1991**.

Therefore, it is extremely important for volunteer monitors to continually educate all watershed residents about management practices that can be implemented to minimize phosphorus loading to surface waters.

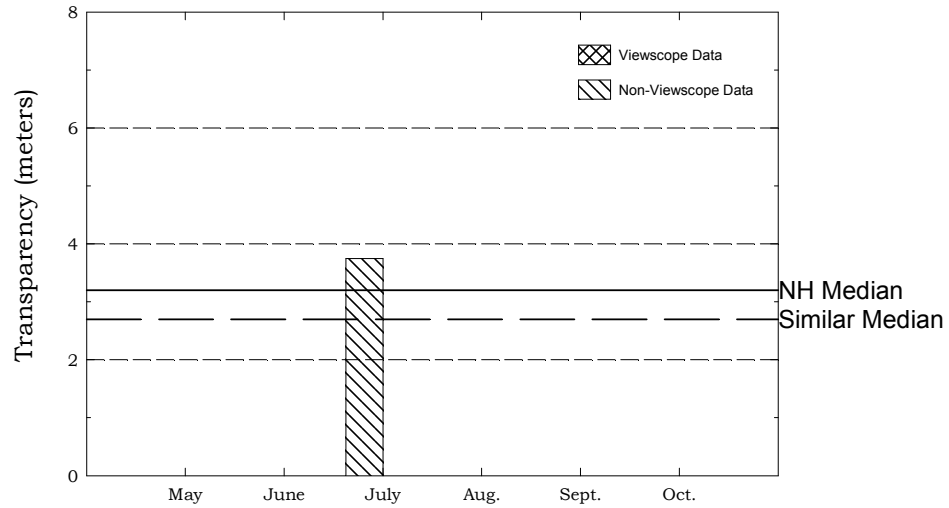
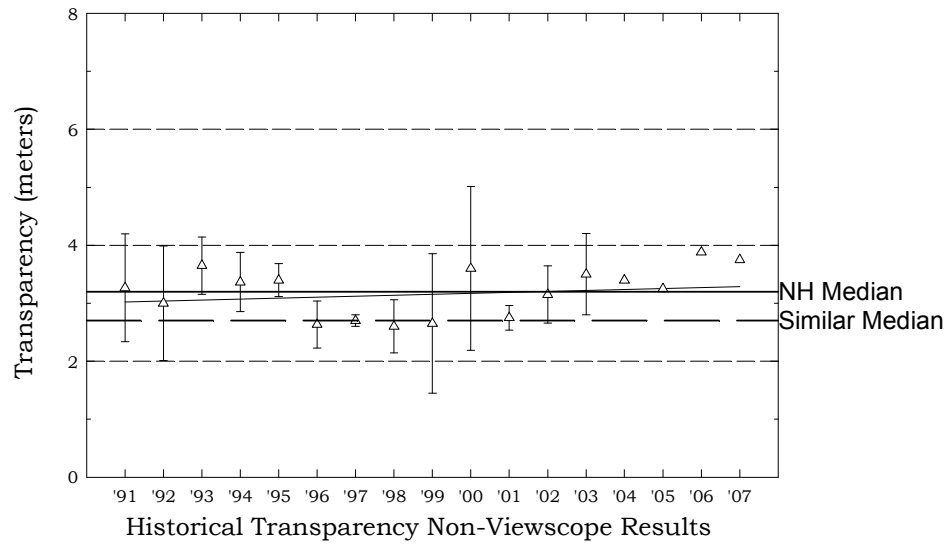
Figure 2. Monthly and Historical Transparency Results

Figure 2 depicts the historical and current year transparency *with and without* the use of a viewscope.

The current year data (the top graph) includes both the non-viewscope and viewscope readings for **2007**.

The current year ***non-viewscope*** in-lake transparency was **3.75 meters in July**.

The transparency was not measured with the ***viewscope*** in **2007**.

The historical data (the bottom graph) show that the **2007** mean non-viewscope transparency is ***slightly greater than*** the state and similar lake medians. Please refer to Appendix D for more information about the similar lake median.

Visual inspection of the historical data trend line (the bottom graph) shows a ***slightly increasing yet variable*** trend. Specifically, the transparency has ***fluctuated between approximately 2.6 and 3.9 meters*** since monitoring began in **1991**.

Typically, high intensity rainfall causes sediment-laden stormwater runoff to flow into surface waters, thus increasing turbidity and decreasing clarity. Efforts should continually be made to stabilize stream banks, pond shorelines, disturbed soils within the watershed, and especially dirt roads located immediately adjacent to the edge of tributaries and the pond. Guides to best management practices that can be implemented to reduce, and possibly even eliminate, nonpoint source pollutants, are available from DES upon request.

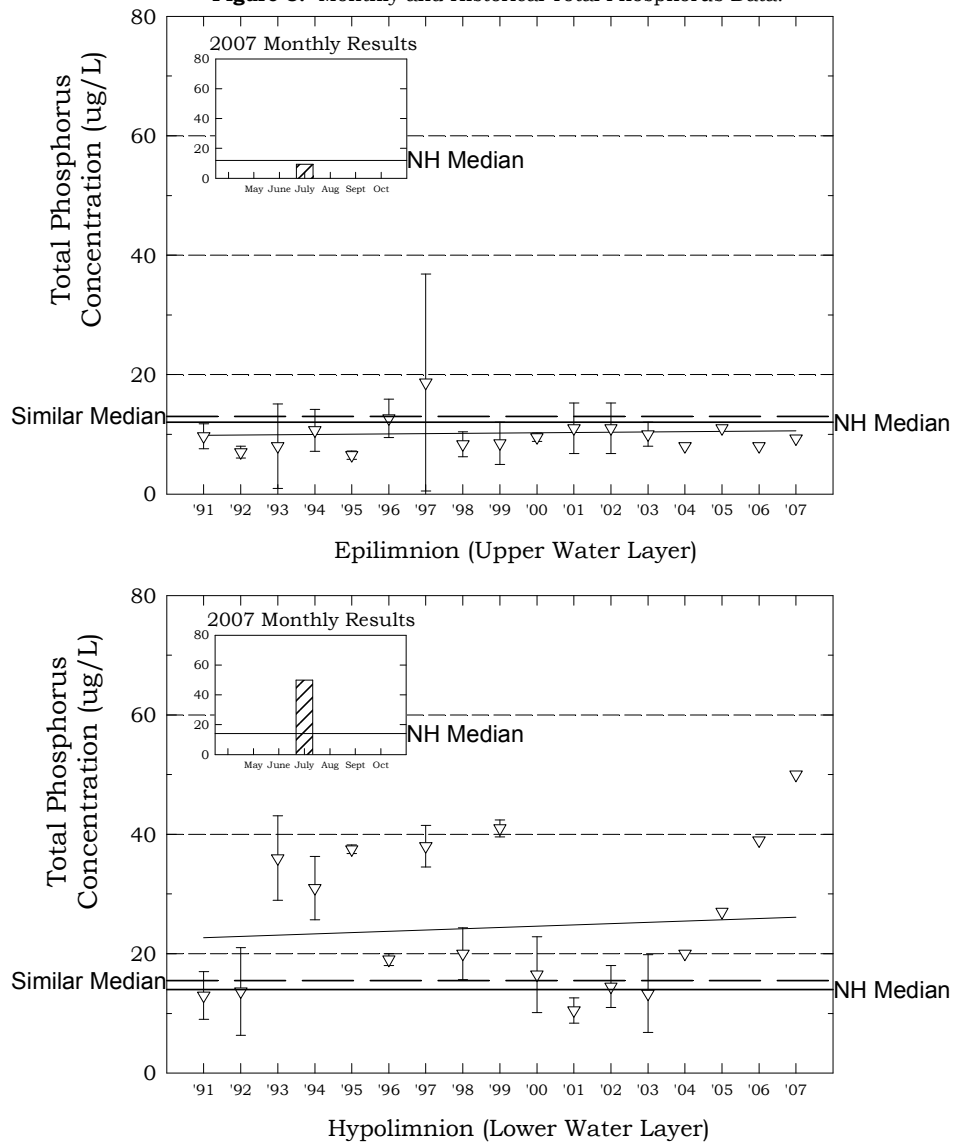
Figure 3. Monthly and Historical Total Phosphorus Data.

The graphs in Figure 3 depict the historical amount of epilimnetic (upper layer) and hypolimnetic (lower layer) total phosphorus concentrations; the inset graphs depict current year total phosphorus data.

The current year data for the epilimnion (the top inset graph) show that the phosphorus concentration was **9 ug/L in July**.

The historical data show that the **2007** mean epilimnetic phosphorus concentration is ***slightly less than*** the state and similar lake medians. Refer to Appendix D for more information about the similar lake median.

The current year data for the hypolimnion (the bottom inset graph) show that the phosphorus concentration was **50 ug/L in July**; the highest phosphorus concentration measured since monitoring began.

The historical data show that the **2007** mean hypolimnetic phosphorus concentration is ***much greater than*** the state and similar lake medians. Please refer to Appendix D for more information about the similar lake median.

Overall, visual inspection of the historical data trend line for the epilimnion shows a ***relatively stable*** phosphorus trend. Specifically, the mean annual epilimnetic phosphorus concentration has ***remained between approximately 6.5 and 18.7 ug/L*** since monitoring began in **1991**.

Overall, visual inspection of the historical data trend line for the hypolimnion shows an ***increasing yet variable*** phosphorus trend since monitoring began. Specifically the mean annual concentration has ***luctuated between approximately 10.5 and 50 ug/L*** since monitoring began in **1991**.

One of the most important approaches to reducing phosphorus loading to a waterbody is to continually educate watershed residents about the watershed sources of phosphorus and how excessive phosphorus loading can negatively affect the ecology and the recreational, economical, and ecological value of lakes and ponds.
